UNDERWATER BRIDGE INSPECTION REPORT

STRUCTURE NO. 02531

RUM RIVER

DISTRICT 5 - ANOKA COUNTY

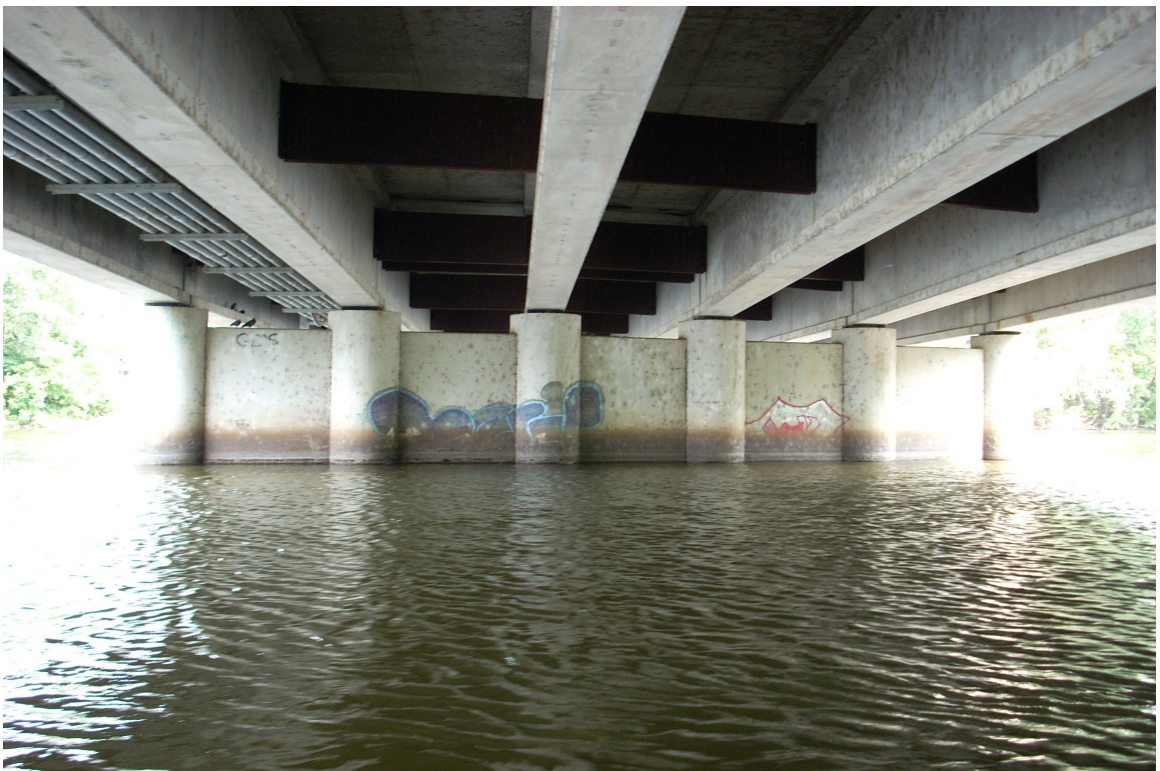
Photograph 2. View of Pier 1, Looking Northeast.

- (A) Minor local scour depressions, 2 feet in radius and 1 foot deep, were found at the downstream end of the downstream column of Pier 2.
- (B) Minor scour depressions were observed around all of Pier 1 columns with a maximum radius of 2 feet and a maximum depth of 1.5 feet. The extent of the scour diminished gradually towards the downstream end of the pier.

- (E) A light accumulation of timber debris consisting of 3-inch-diameter and smaller branches was observed around the entire perimeter of Pier 1. Pier 2 had a light accumulation of timber debris consisting of 6-inch-diameter and smaller branches observed around the entire perimeter. The timber debris around both piers extended from the channel bottom up 2 feet and 3 feet out from both the faces and noses of the piers.

- (A) Monitor the drift at the piers during future inspections and if found to be progressing removal of the accumulations of timber debris from around the piers may be warranted at that time.
- (B) Reinspect the submerged substructure units at the normal maximum recommended (NBIS) interval of five (5) years.

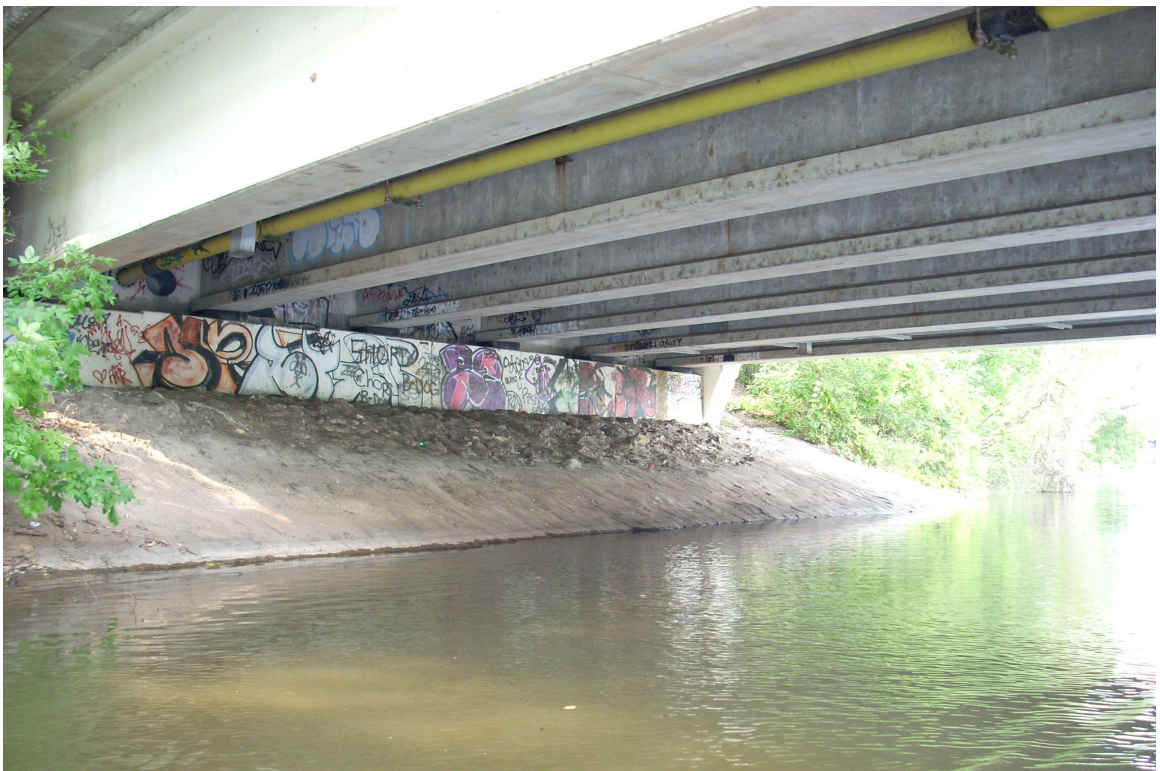
Photograph 4. View of West Slopewall, Looking South.

- (C) Portions of the concrete edge of the east embankment slope protection were broken off with undermining along the embankment having a maximum height of 2 feet and maximum horizontal penetration of 1.5 feet. The west embankment slope protection exhibited similar undermining with a maximum height of 1 foot and a maximum horizontal penetration of 1 foot.

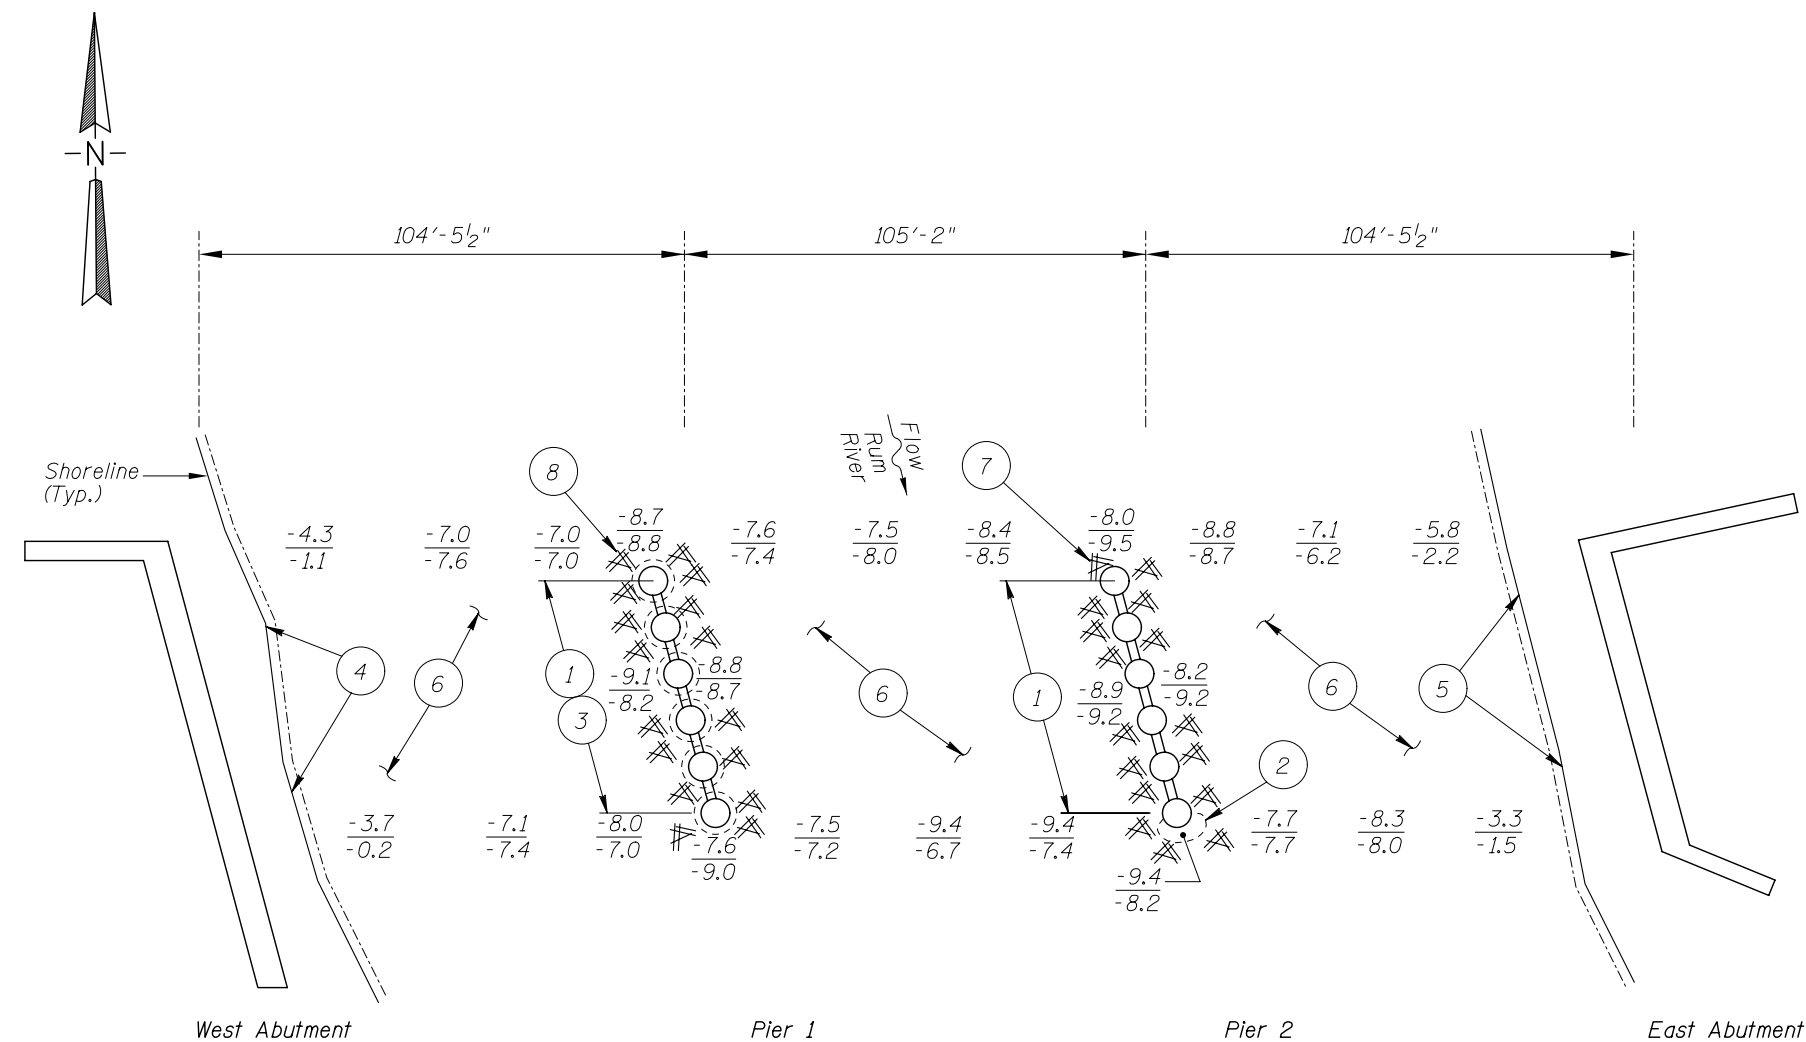
INSPECTION AND SOUNDING PLAN

- 1 The concrete surfaces of the columns and webwalls of both piers were generally smooth and sound with random minor areas of poor consolidation with up to 1/4 inch penetration.

- 2 Minor scour pocket, 2 feet in radius by 1 foot deep, was observed at the downstream end of the downstream column of Pier 2.
- 3 Minor scour pockets were observed around all of Pier 1 columns with a maximum radius of 2 feet and a maximum depth of 1.5 foot, diminishing in size towards the downstream end of the pier.

- 4 Portions of the concrete edge of the west slope protection were broken off with undermining along the embankment up to a maximum height of 1 foot and maximum horizontal penetration under the protection of 1 foot.

- 5 Portions of the concrete edge of the east slope protection were broken off with undermining along the embankment up to a maximum height of 2 feet and maximum horizontal penetration under the protection of 1.5 foot.

- 6 The channel bottom material consisted of soft sand with a maximum probe rod penetration of 1 foot around the substructure units.
- 7 A minor accumulation of timber debris, consisting of 6 inch diameter and smaller branches, was observed around the entire Pier 2 from the channel bottom up 2 feet and from the pier faces and noses out 3 feet.

- 8 A minor accumulation of timber debris, consisting of 3 inch diameter and smaller branches, was observed around the entire Pier 1 from the channel bottom up 2 feet and from the pier faces and noses out 3 feet.
